**DRAFT CERCLA EMERGENCY RESPONSE ACTION REPORT
APEX FACILITY FIRE SITE
APEX, WAKE COUNTY, NORTH CAROLINA
EPA CONTRACT NO. EP-W-05-054
TDD NO. TTEMI-05-001-0023**

**U.S. ENVIRONMENTAL PROTECTION AGENCY
Region 4, Emergency Response and Removal Branch
61 Forsyth Street, SW, 11th Floor
Atlanta, GA 30303**

**Tetra Tech EM Inc.
Superfund Technical Assessment and Response Team Region 4
1955 Evergreen Blvd., Suite 300
Duluth, GA 30096**

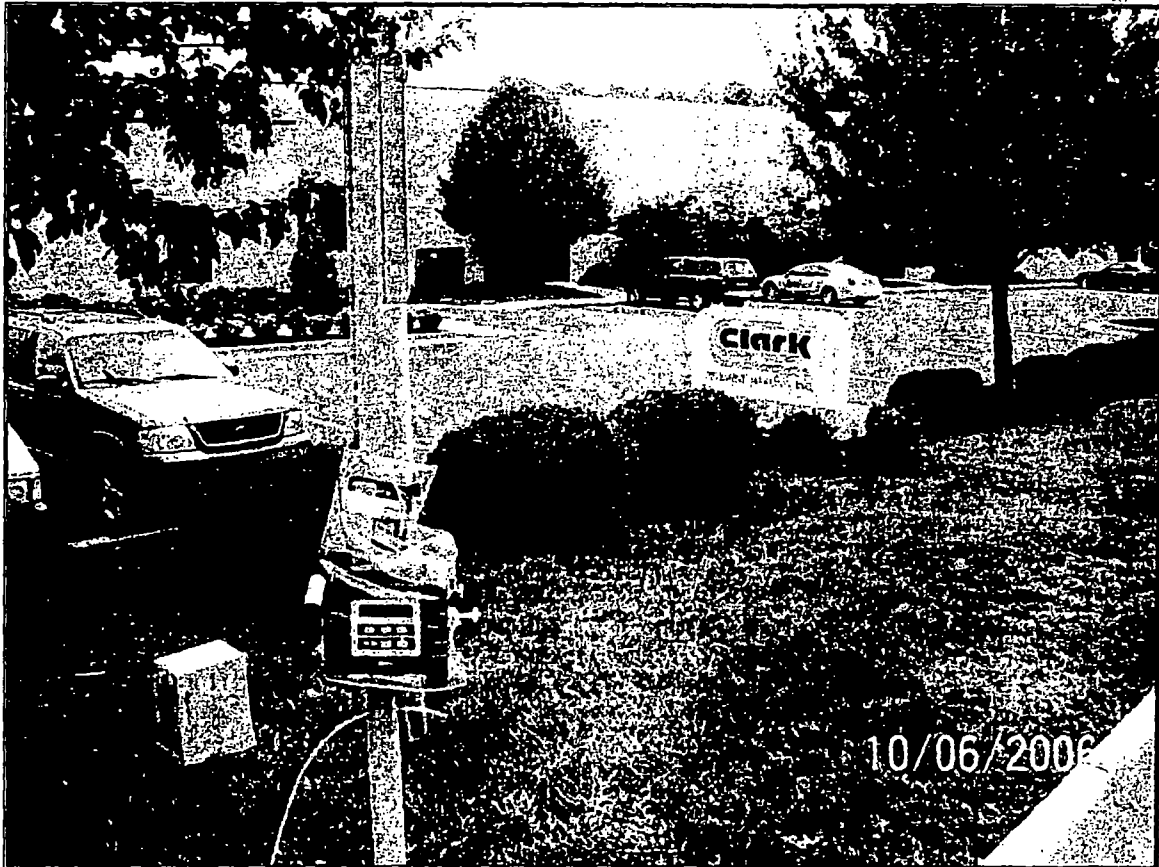
OFFICIAL PHOTOGRAPH NO. 2 U.S. ENVIRONMENTAL PROTECTION AGENCY

Description: CTEH air monitoring location 3 at Industrial Boulevard east of the EQ facility. Note the air sampling pump above the AreaRAE.

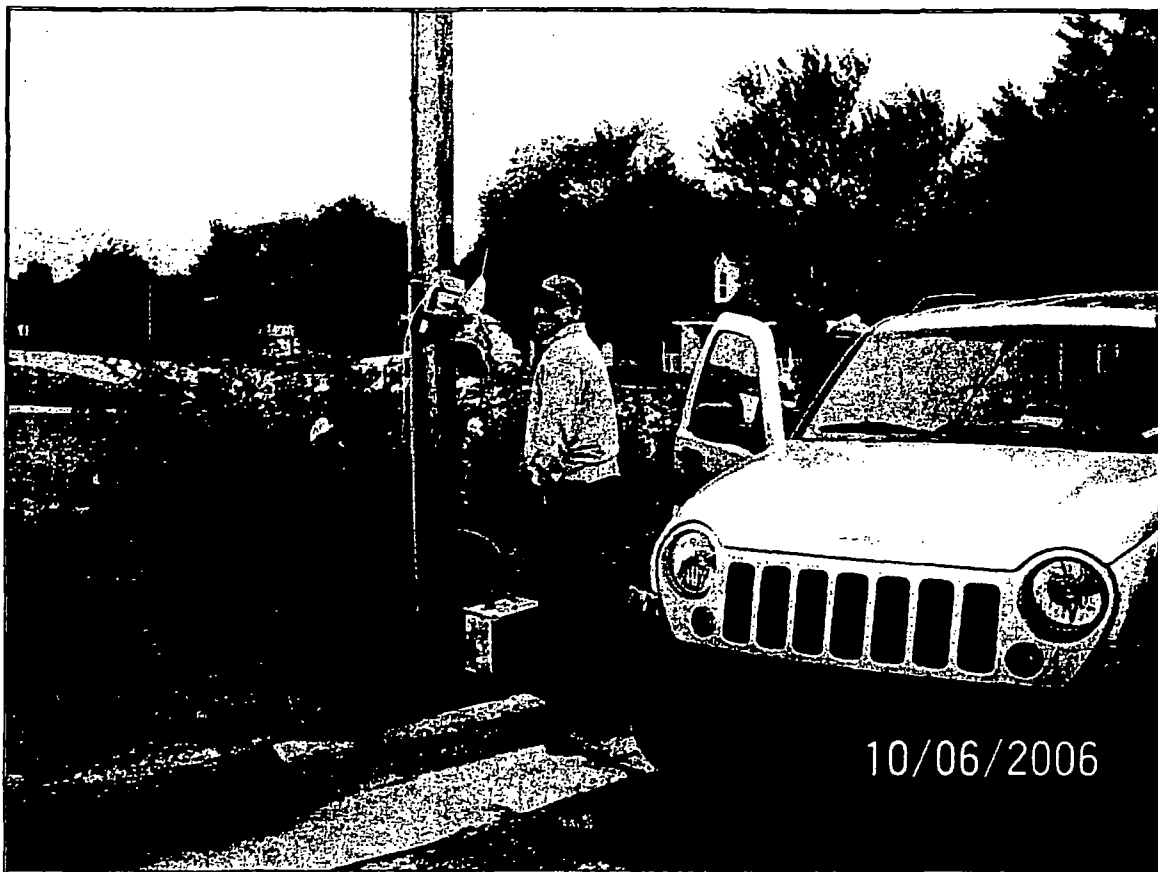
OFFICIAL PHOTOGRAPH NO. 5
U.S. ENVIRONMENTAL PROTECTION AGENCY

Description: START members David Reyna and Darius Soltes at CTEH air monitoring location 6 at the intersection of George Street and Briarcliff.

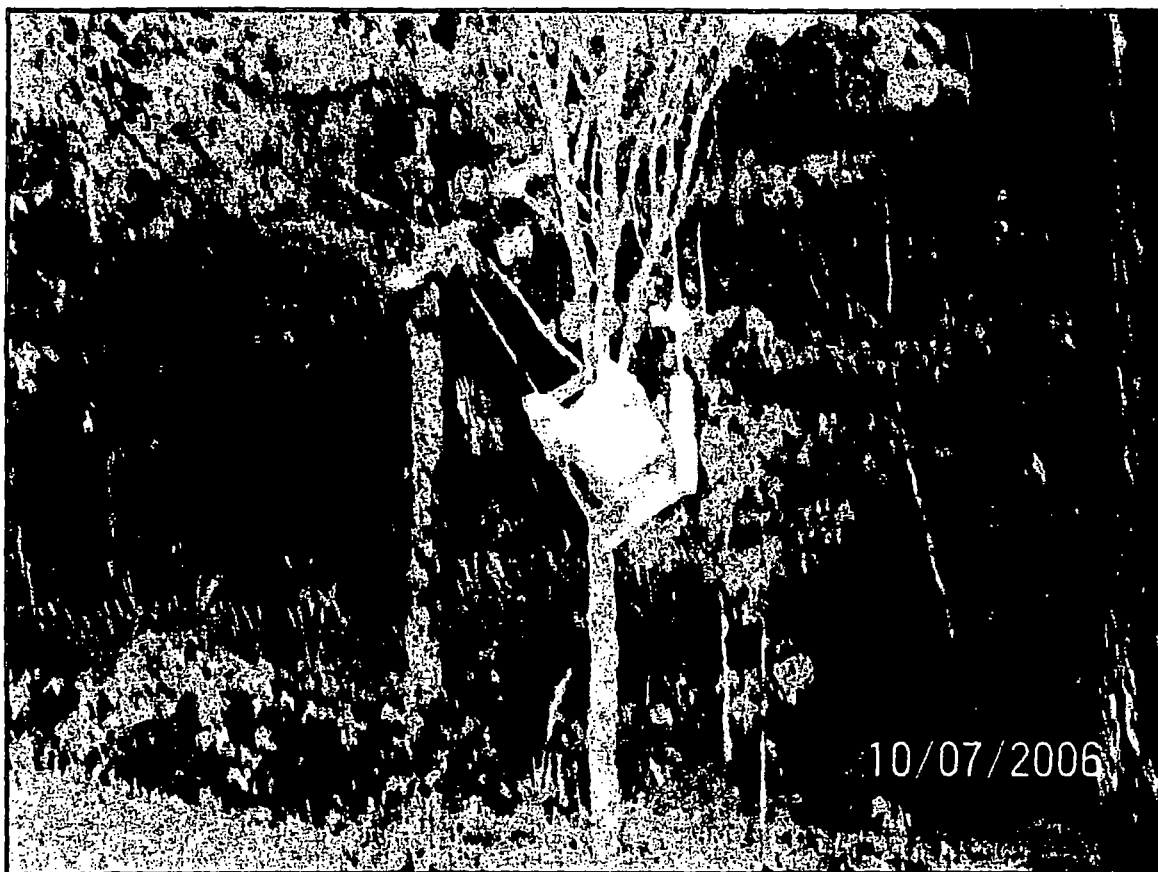
OFFICIAL PHOTOGRAPH NO. 10
U.S. ENVIRONMENTAL PROTECTION AGENCY

Description: CTEH air monitoring location 17 north of the facility along the tree line.

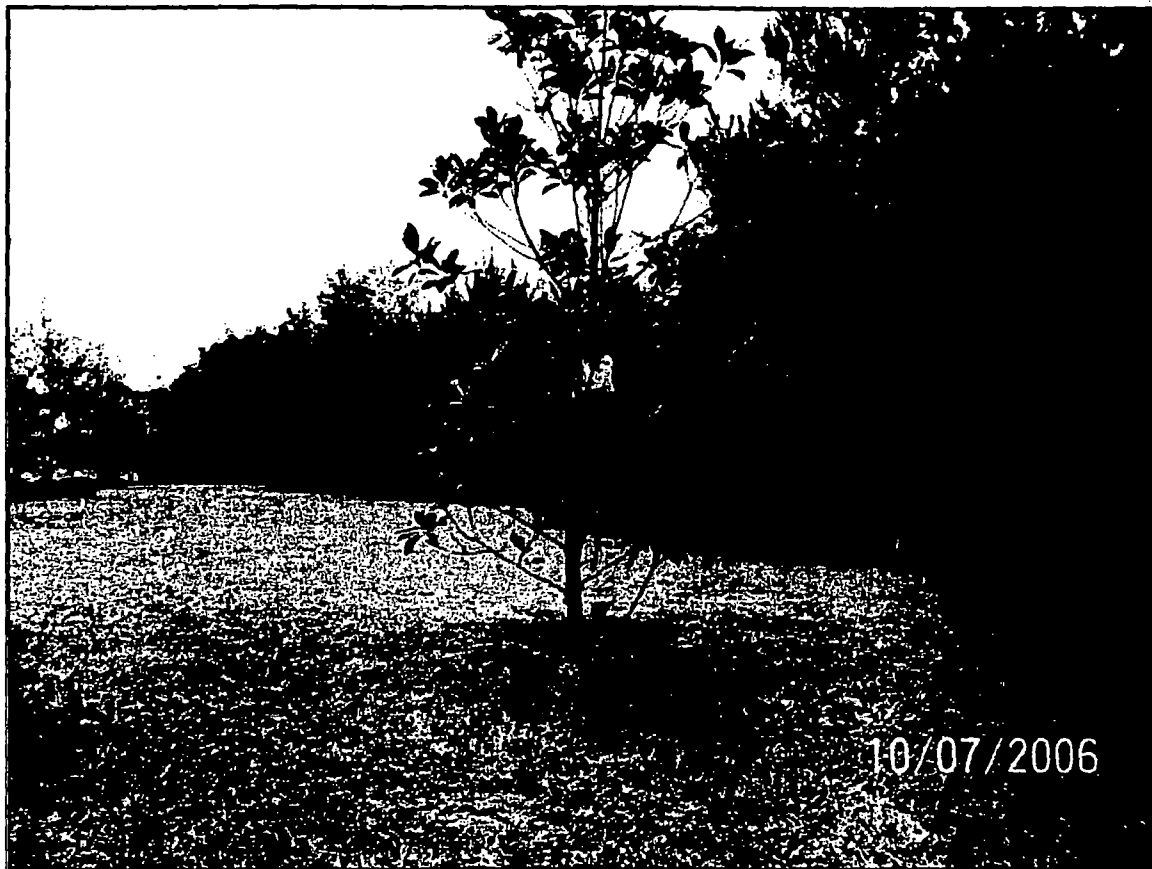
OFFICIAL PHOTOGRAPH NO. 12
U.S. ENVIRONMENTAL PROTECTION AGENCY

Description: CTEH air monitoring location 19 off Schieffelin Road northwest of the facility

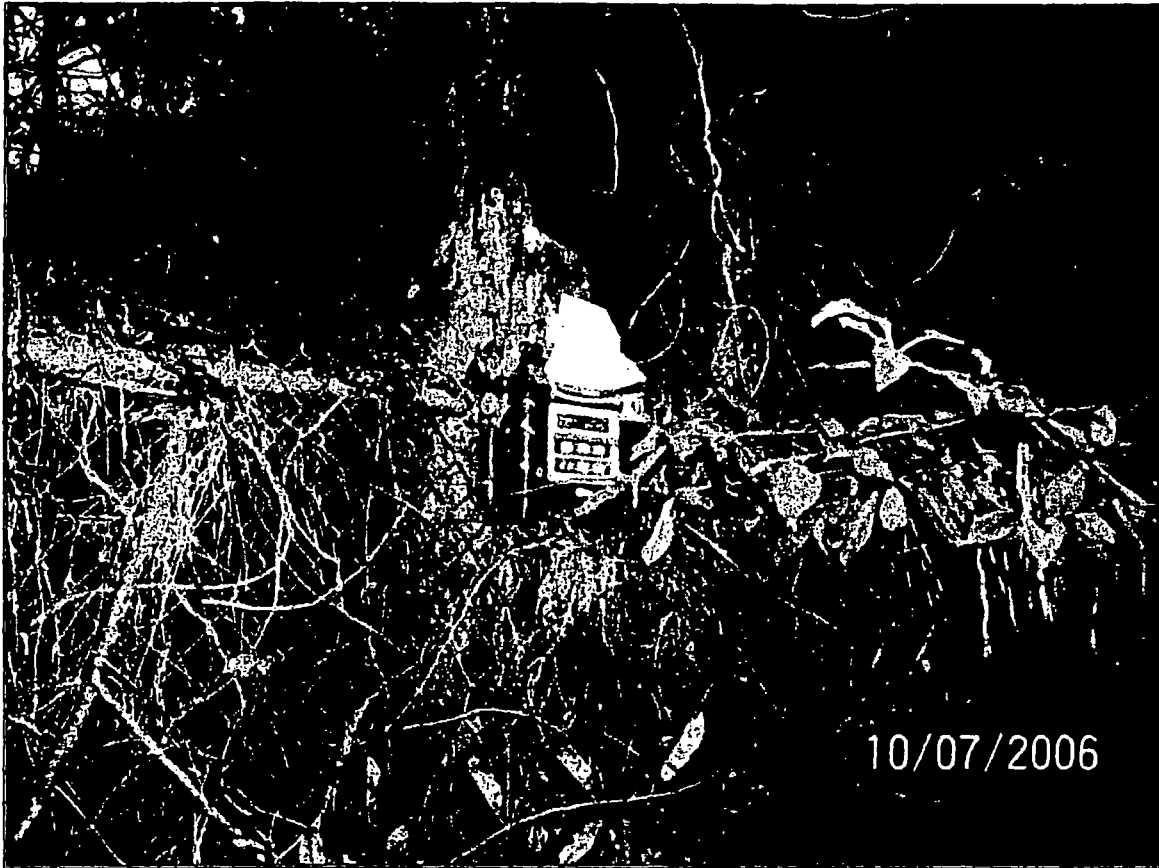
OFFICIAL PHOTOGRAPH NO. 14
U.S. ENVIRONMENTAL PROTECTION AGENCY

Description: CTEH air monitoring location 21 behind Capitol Coffee Systems, Inc., at 1000 Investment Boulevard, southwest of the facility.

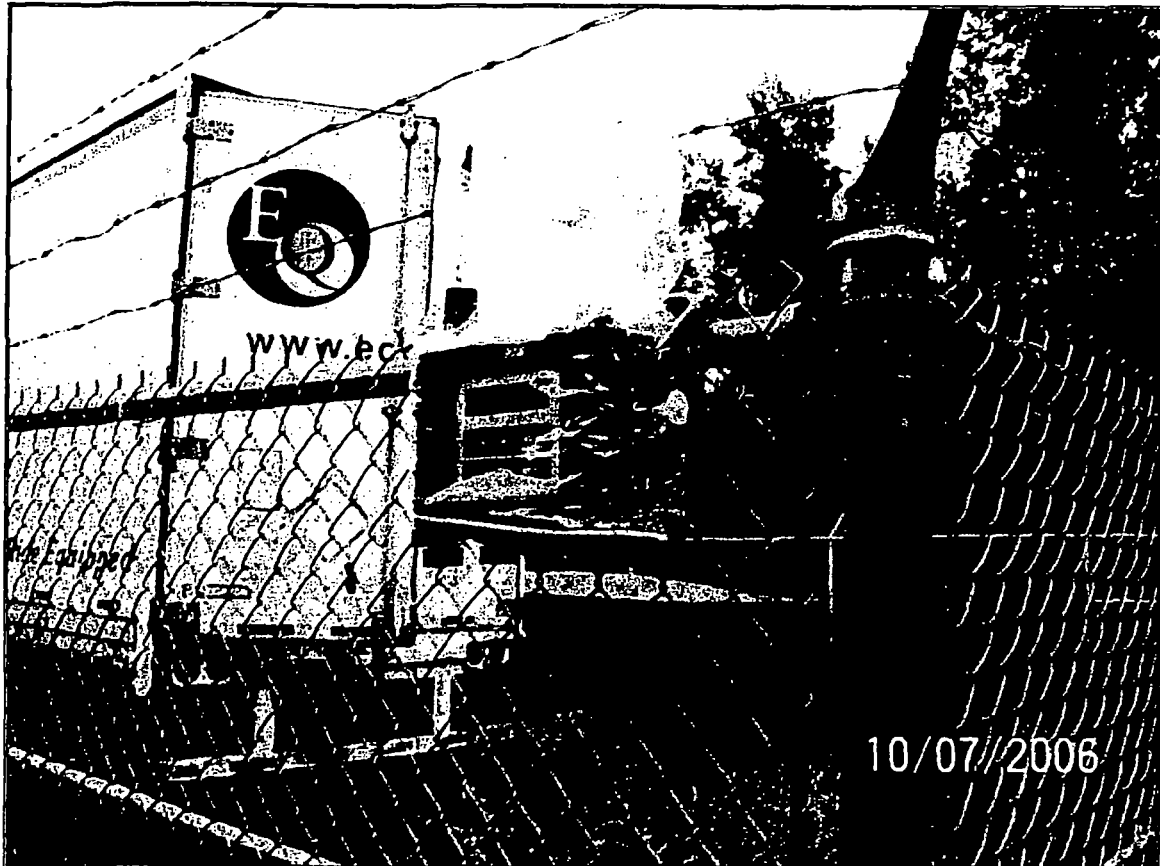
OFFICIAL PHOTOGRAPH NO. 15
U.S. ENVIRONMENTAL PROTECTION AGENCY

Description: CTEH air monitoring location 22 on Investment Boulevard southeast of the facility.

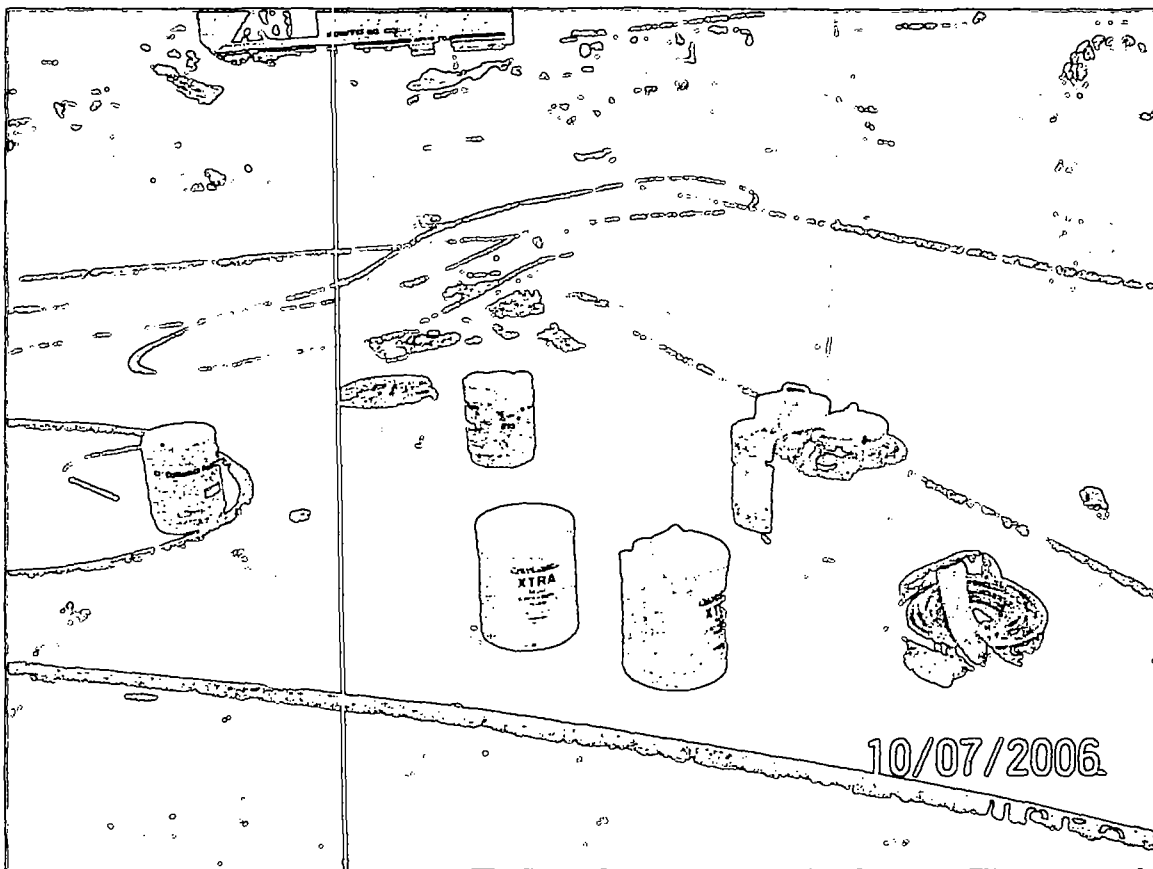
OFFICIAL PHOTOGRAPH NO. 18
U.S. ENVIRONMENTAL PROTECTION AGENCY

Description: Fire fighting chemicals, foam, and hoses staged adjacent to the EQ storage facility.

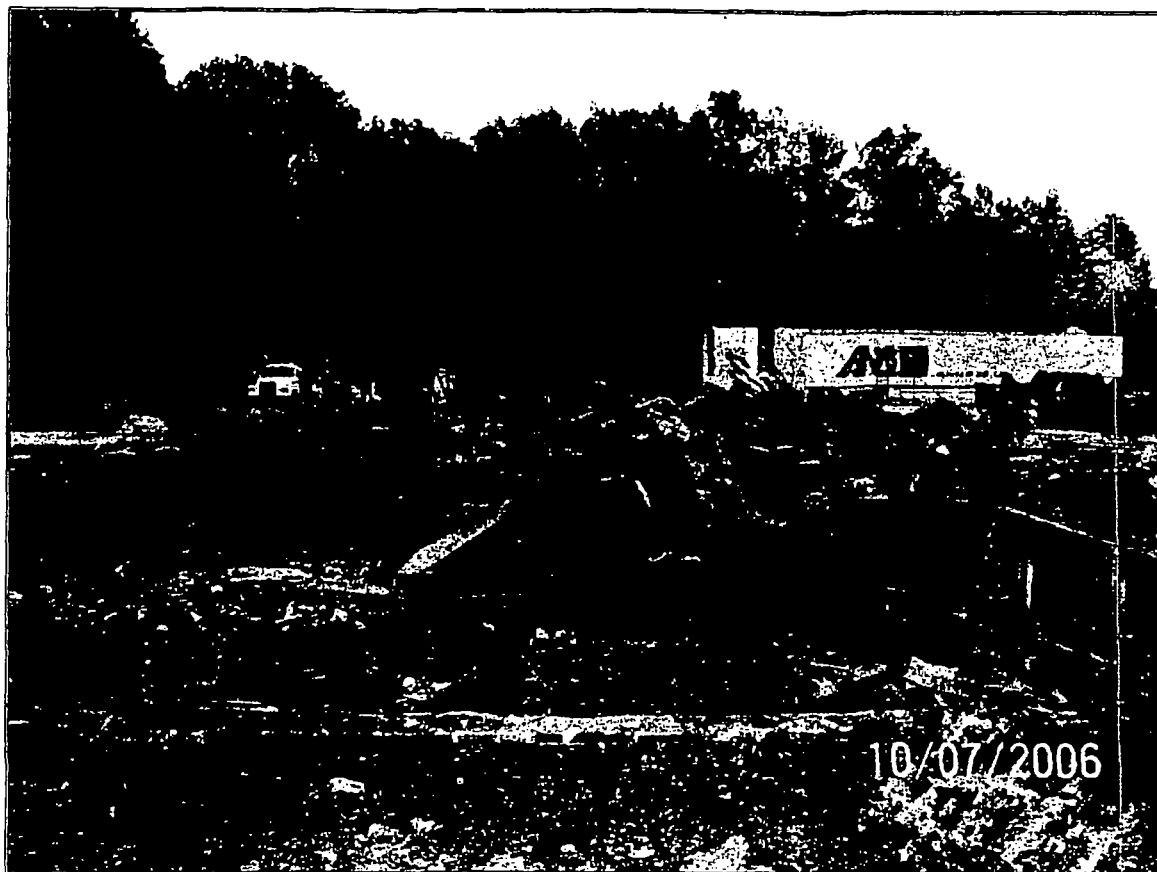
OFFICIAL PHOTOGRAPH NO. 22
U.S. ENVIRONMENTAL PROTECTION AGENCY

Description: 55-Gallon drums and other debris at the EQ storage facility.

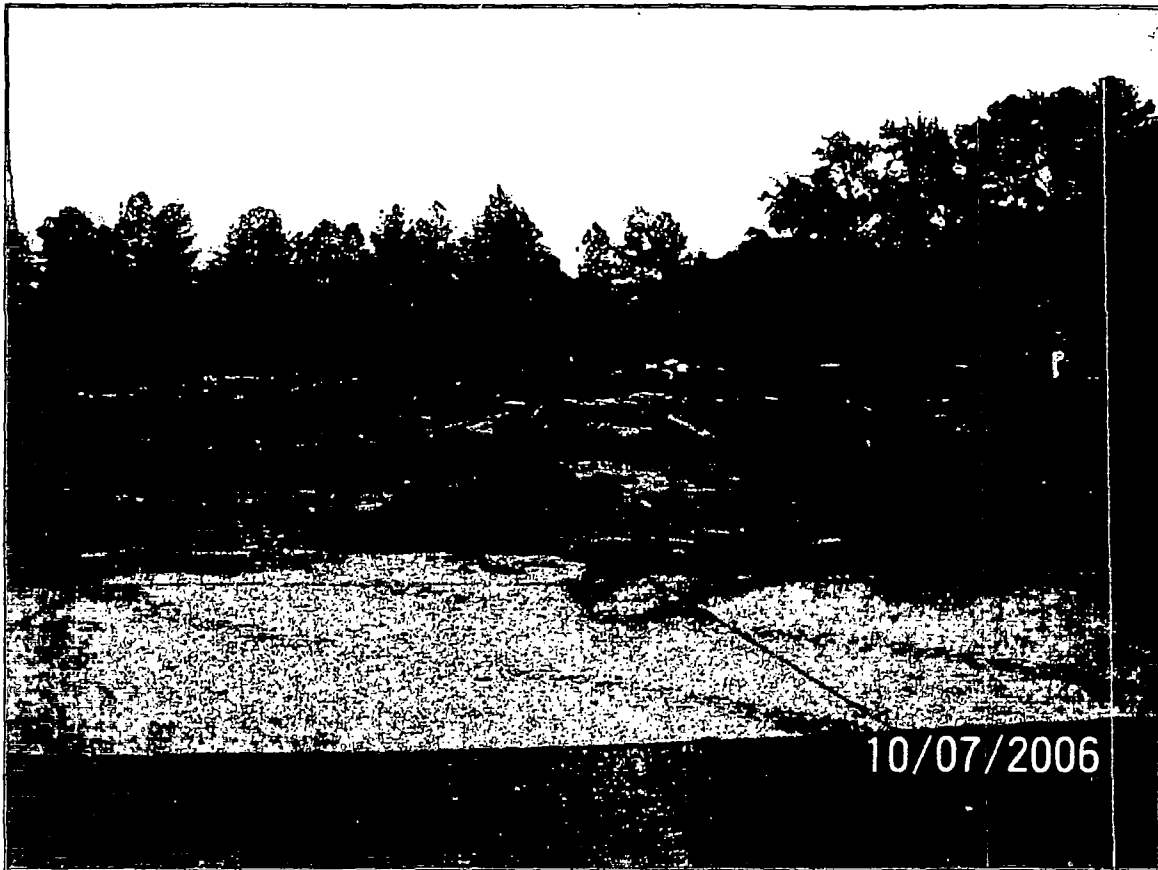
OFFICIAL PHOTOGRAPH NO. 23
U.S. ENVIRONMENTAL PROTECTION AGENCY

Description: Earthen berms were created to prevent water runoff.

At about 2100, USES began tearing down the building with heavy equipment and spraying foam onto the burning material. Berms were used to collect the water runoff, and USES used vacuum trucks to transfer the water to a frac tank located down the road from the facility. At about 0030, USES declared the fire extinguished, with only a few isolated pockets of smoldering debris. USES continued to dismantle the building throughout the night. Occasional flare-ups occurred, but they were quickly contained by standby crews. By 0500, USES had dismantled the entire structure, and crews broke for rest.

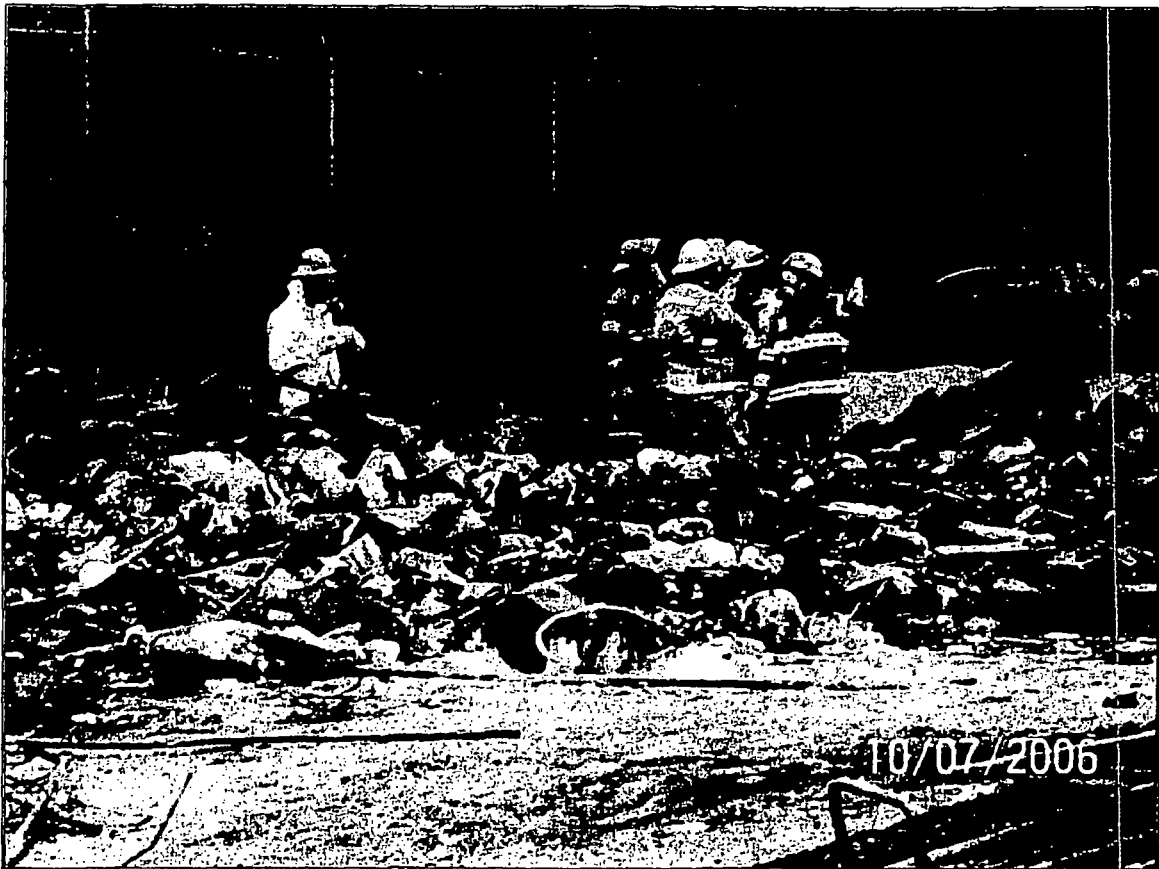
OFFICIAL PHOTOGRAPH NO. 24
U.S. ENVIRONMENTAL PROTECTION AGENCY

Description:	Fire investigation team inspecting debris at the EQ storage facility.		
Location:	EQ Facility Fire, Apex, NC	Date:	October 7, 2006
Orientation:	Northeast	TDD No.:	TTEMI-05-001-0023
Photographer:	Jake Jones, Tetra Tech	Witness:	Darius Soltes, Tetra Tech

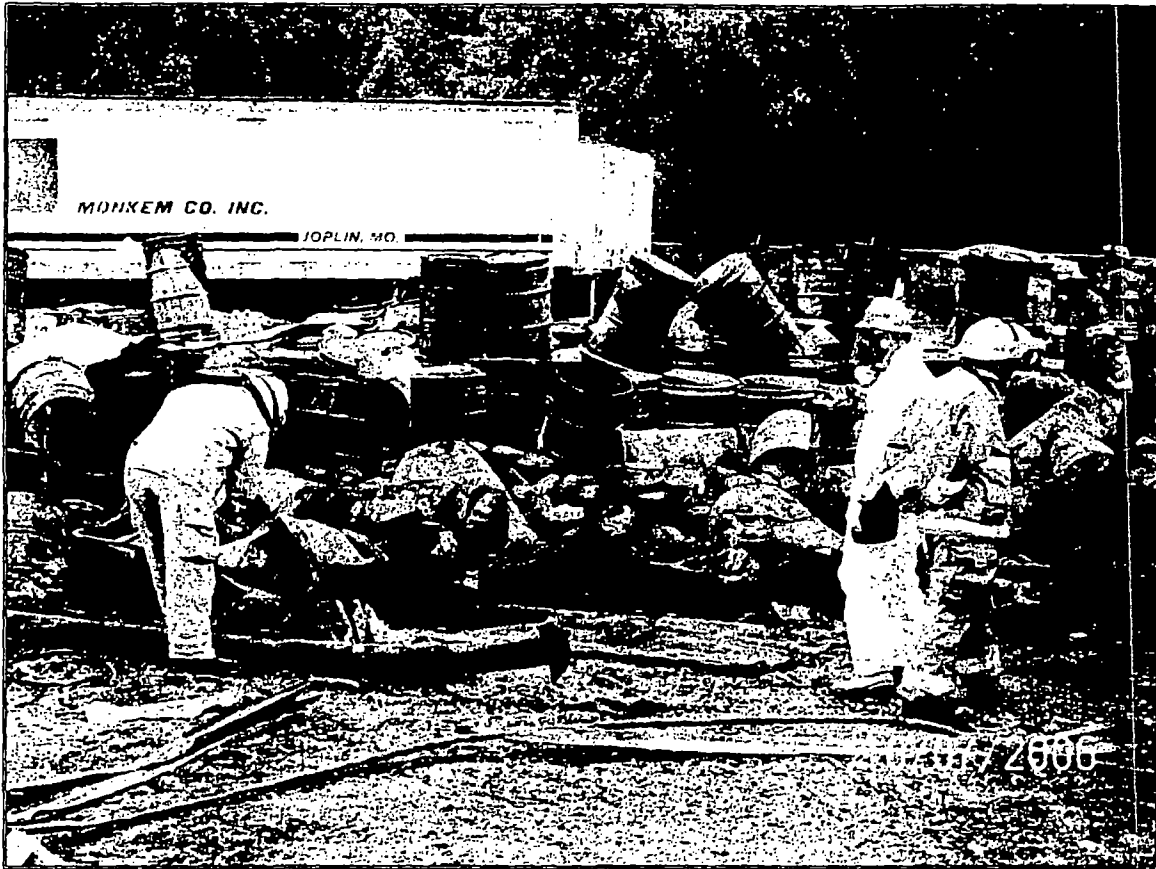
OFFICIAL PHOTOGRAPH NO. 25
U.S. ENVIRONMENTAL PROTECTION AGENCY

Description: Fire investigators inspecting 55-gallon drums at the EQ storage facility.

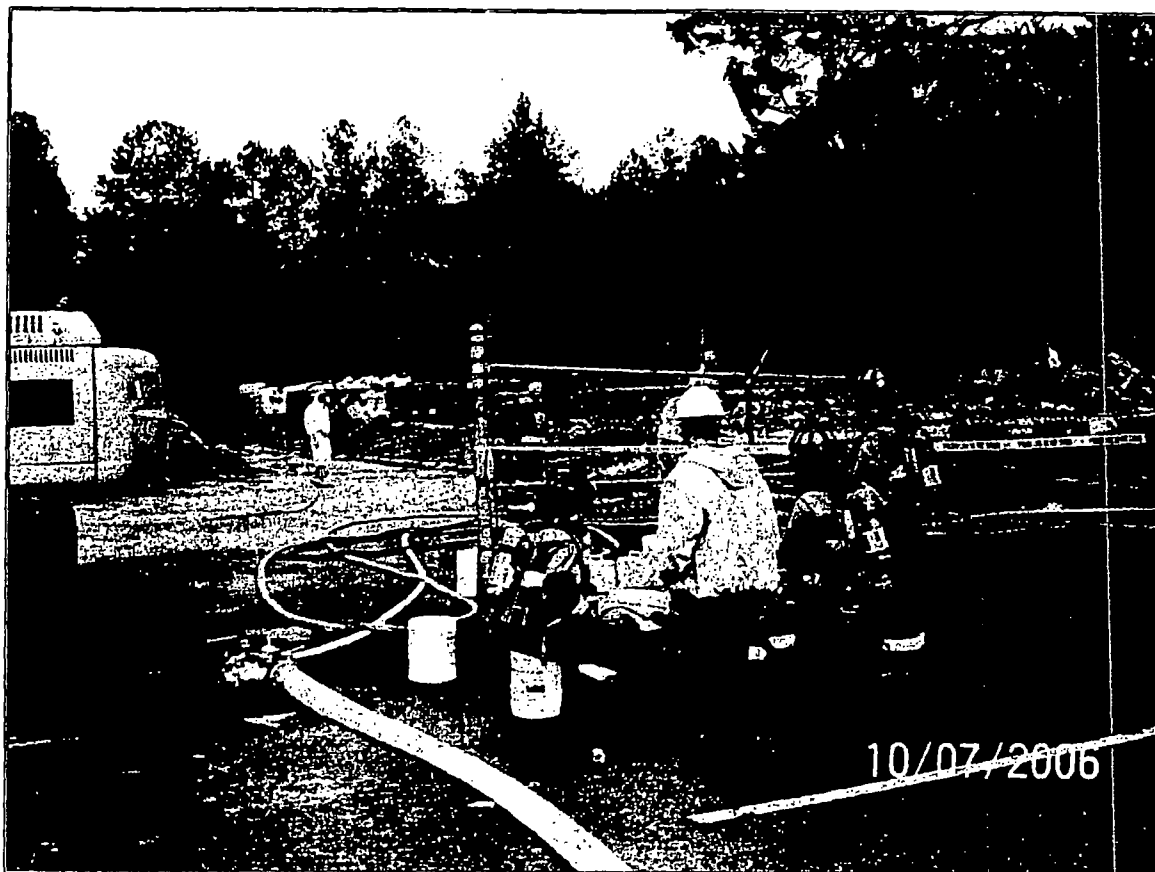
OFFICIAL PHOTOGRAPH NO. 28
U.S. ENVIRONMENTAL PROTECTION AGENCY

Description: The rescue team standing by during the fire investigator entry to determine the possible cause of the fire.
